**2016 Semiannual Groundwater
Monitoring Report**

Palermo Wellfield Superfund Site
Tumwater, Washington

2016 Semiannual Groundwater Monitoring Report

File No. 0180-121-11

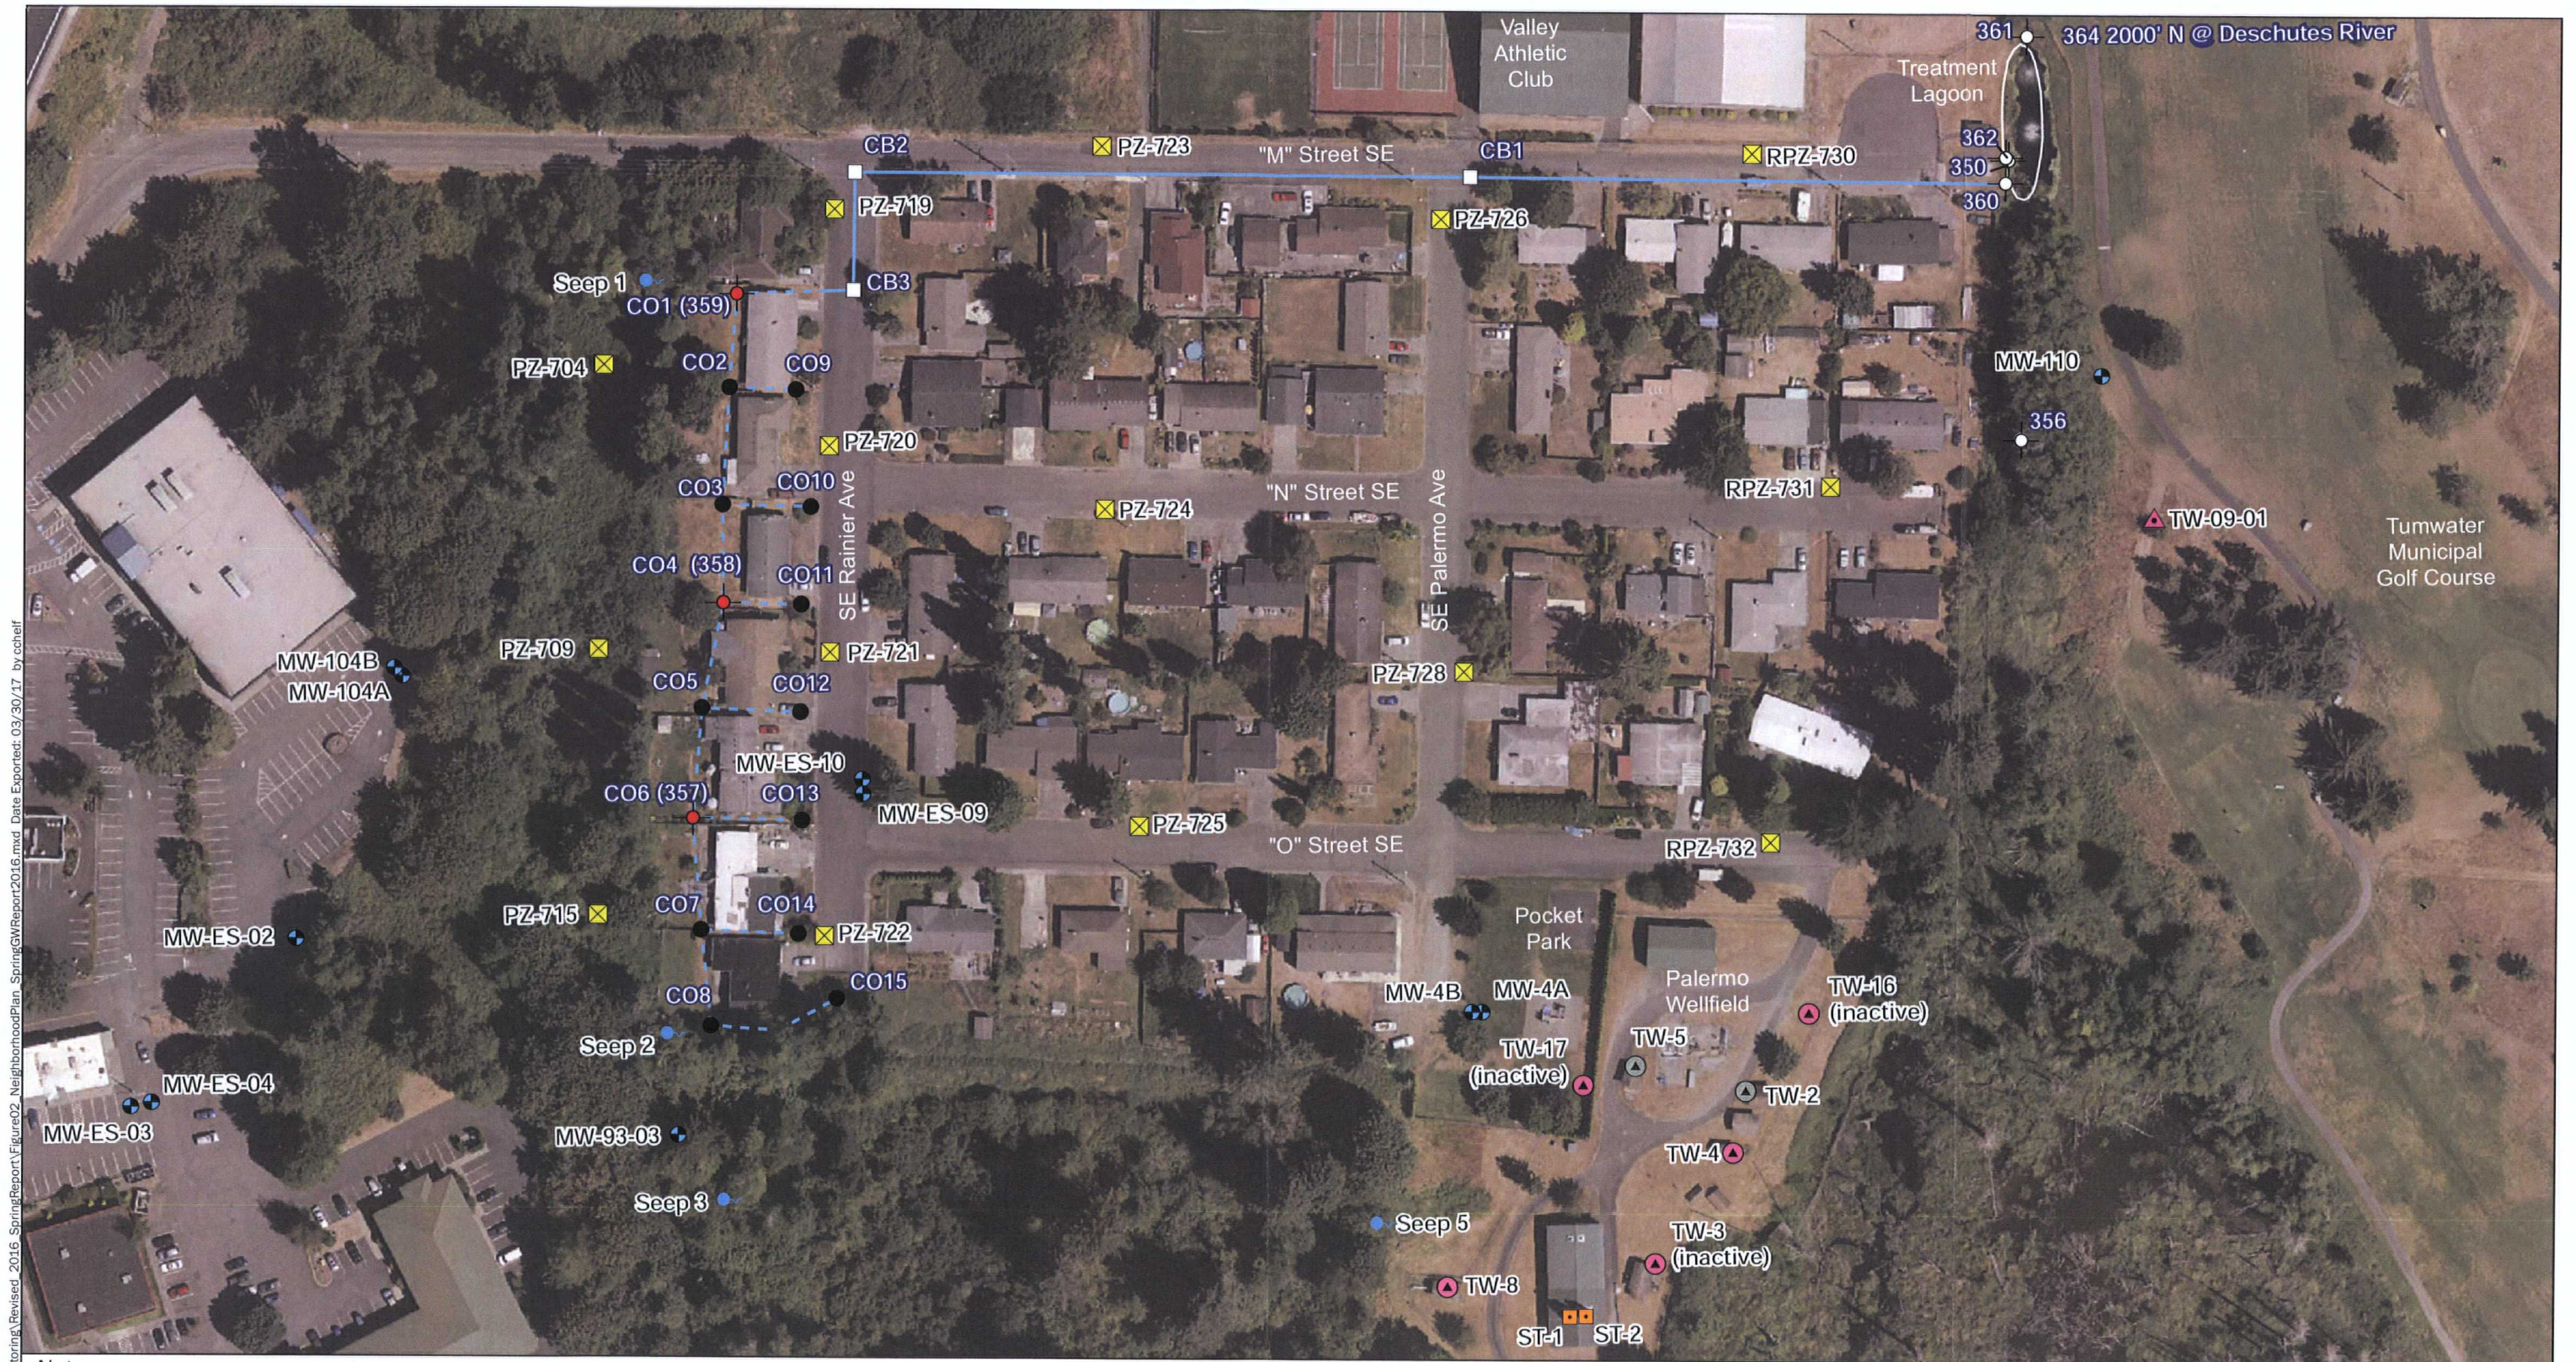
Figure 2

1. The locations of all features shown are approximate.
2. This drawing is for information purposes. It is intended to assist in showing features discussed in an attached document. GeoEngineers, Inc. cannot guarantee the accuracy and content of electronic files. The master file is stored by GeoEngineers, Inc. and will serve as the official record of this communication.
3. TW-3, TW-16 and TW-17 are installed but not operating.

Palermo Neighborhood and Subdrain

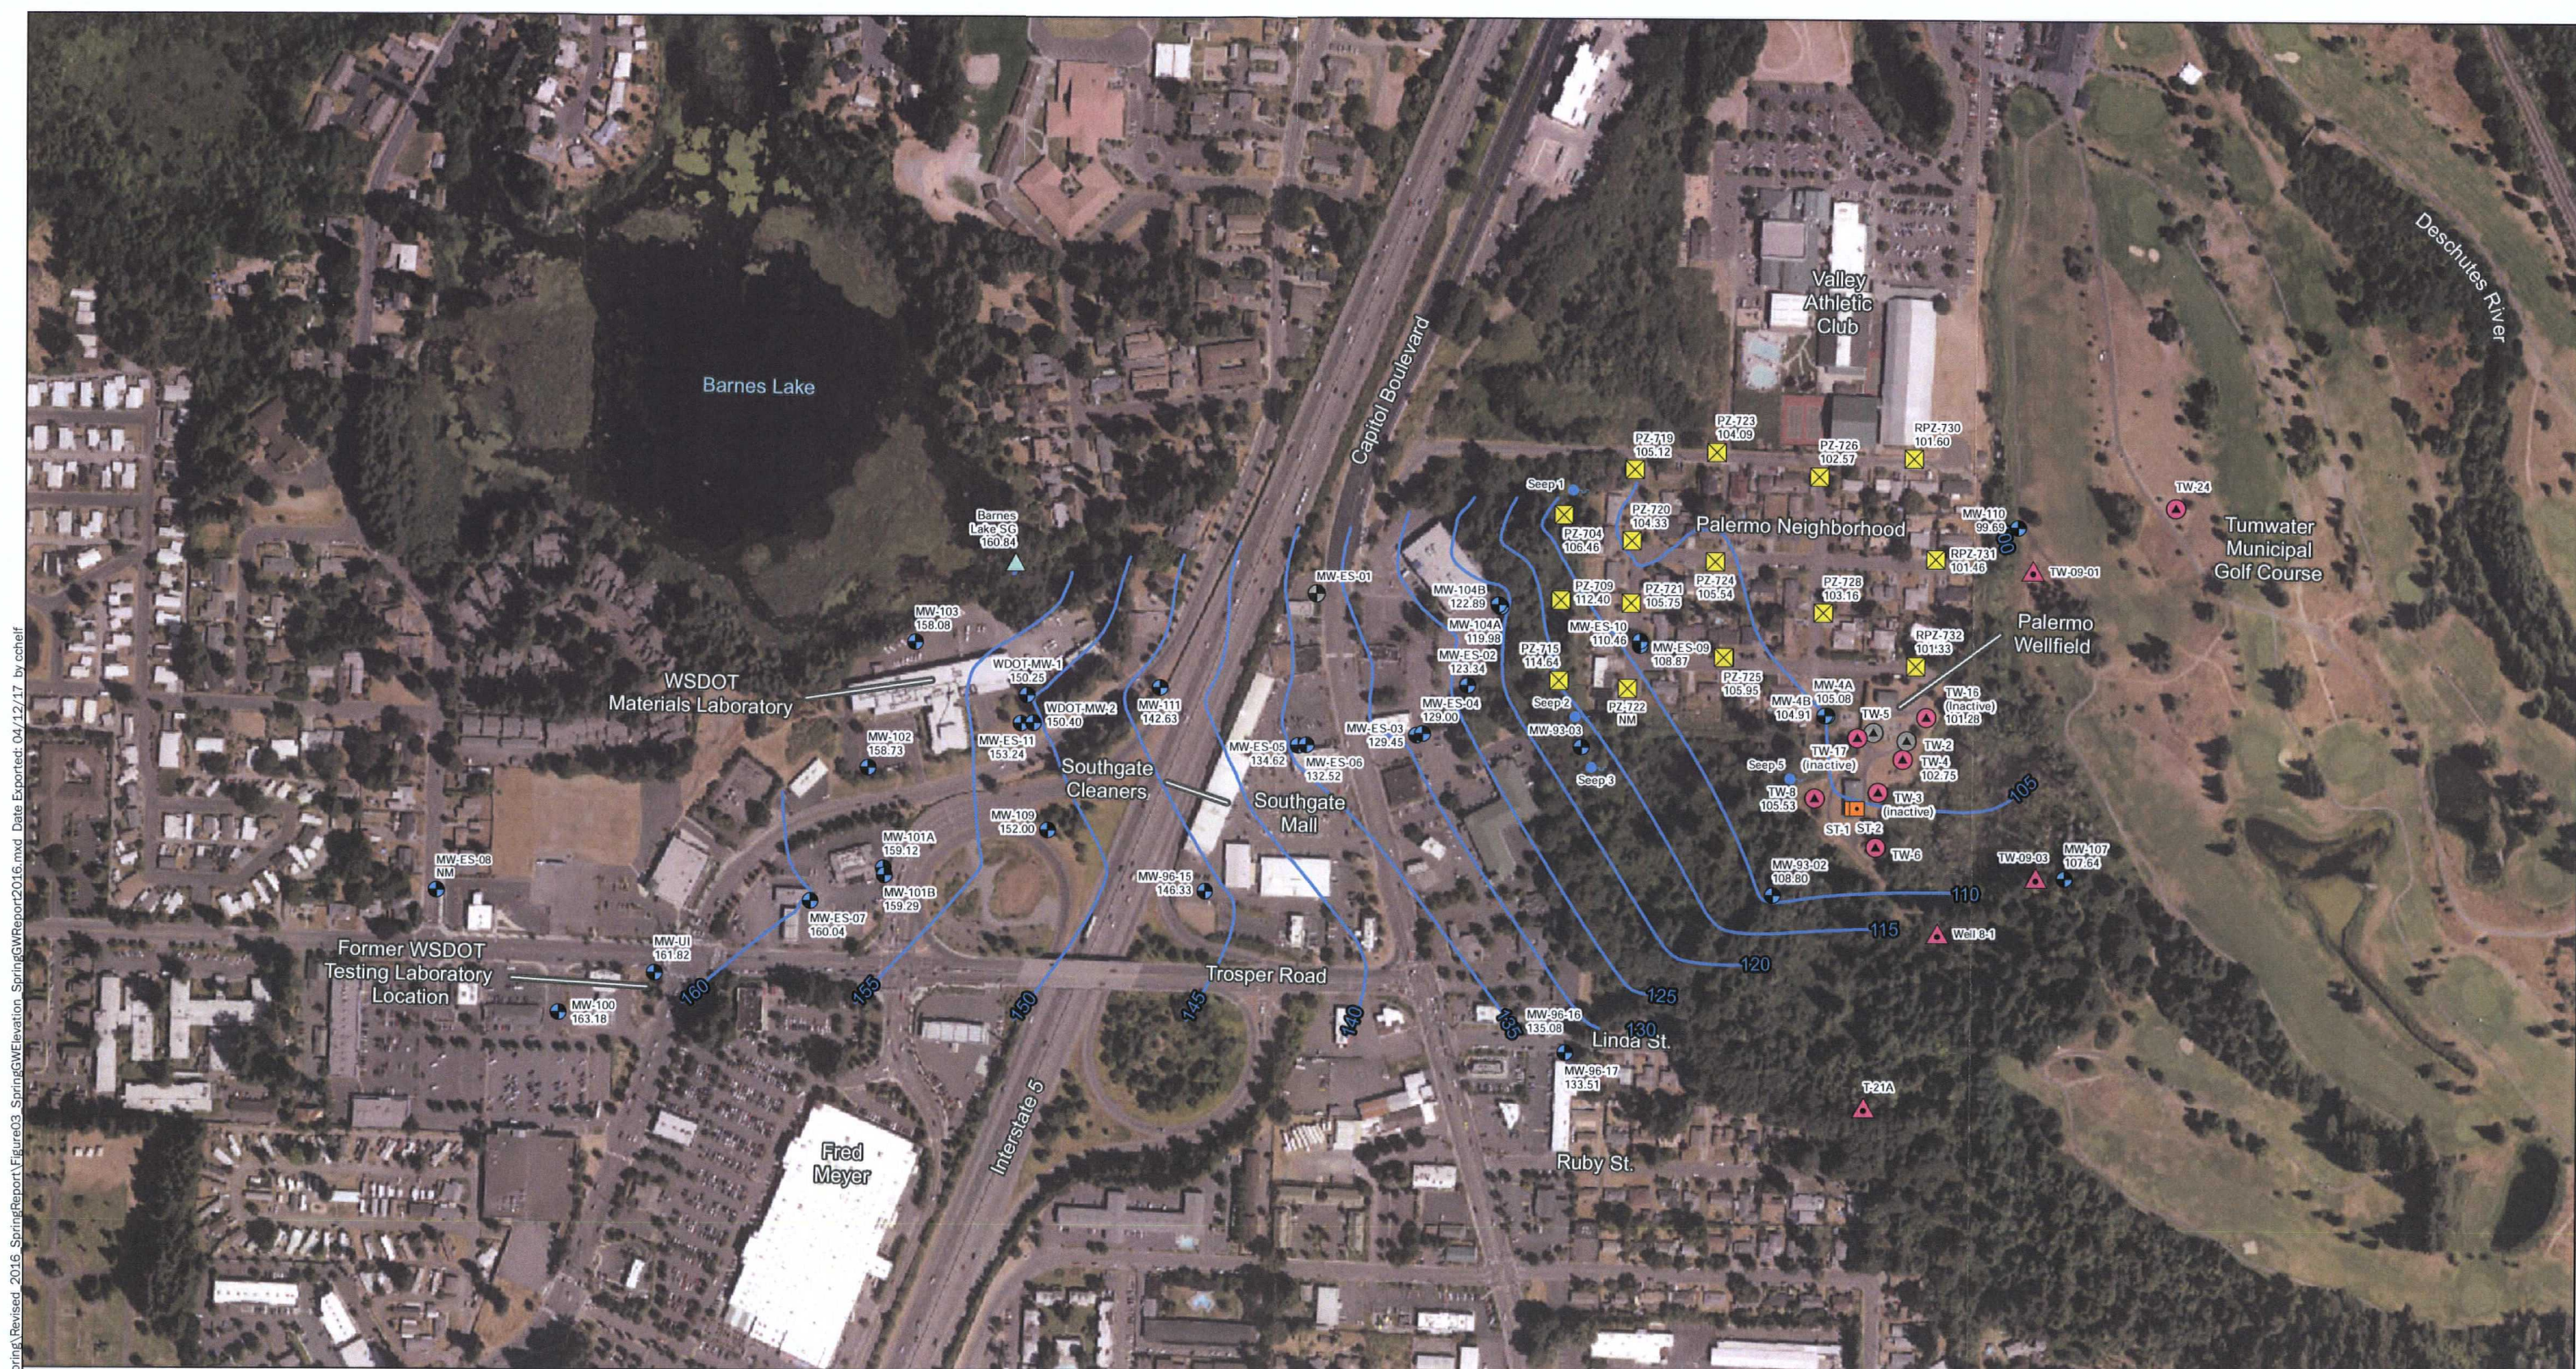
Spring 2016 Generalized Groundwater Elevations	
Palermo Wellfield Superfund Site	
	Figure 3

Notes:
1. TW-3, TW-16 and TW-17 are installed but not operating.
2. Groundwater levels measured April 18, 2016.
3. Groundwater elevation contours estimated using Surfer (Golden Software) 8.0 contouring software using the Natural Neighbor gridding method.

Attributes of monitoring locations and groundwater level elevations observed during the Spring 2016 sampling event are presented in Tables 1 and 2 and Figures 3 and 4. Field forms associated with the sampling are provided in Appendix A. Specific details about the monitoring locations are described below. Deviations from the FSP are outlined in the Section 3.1.5.

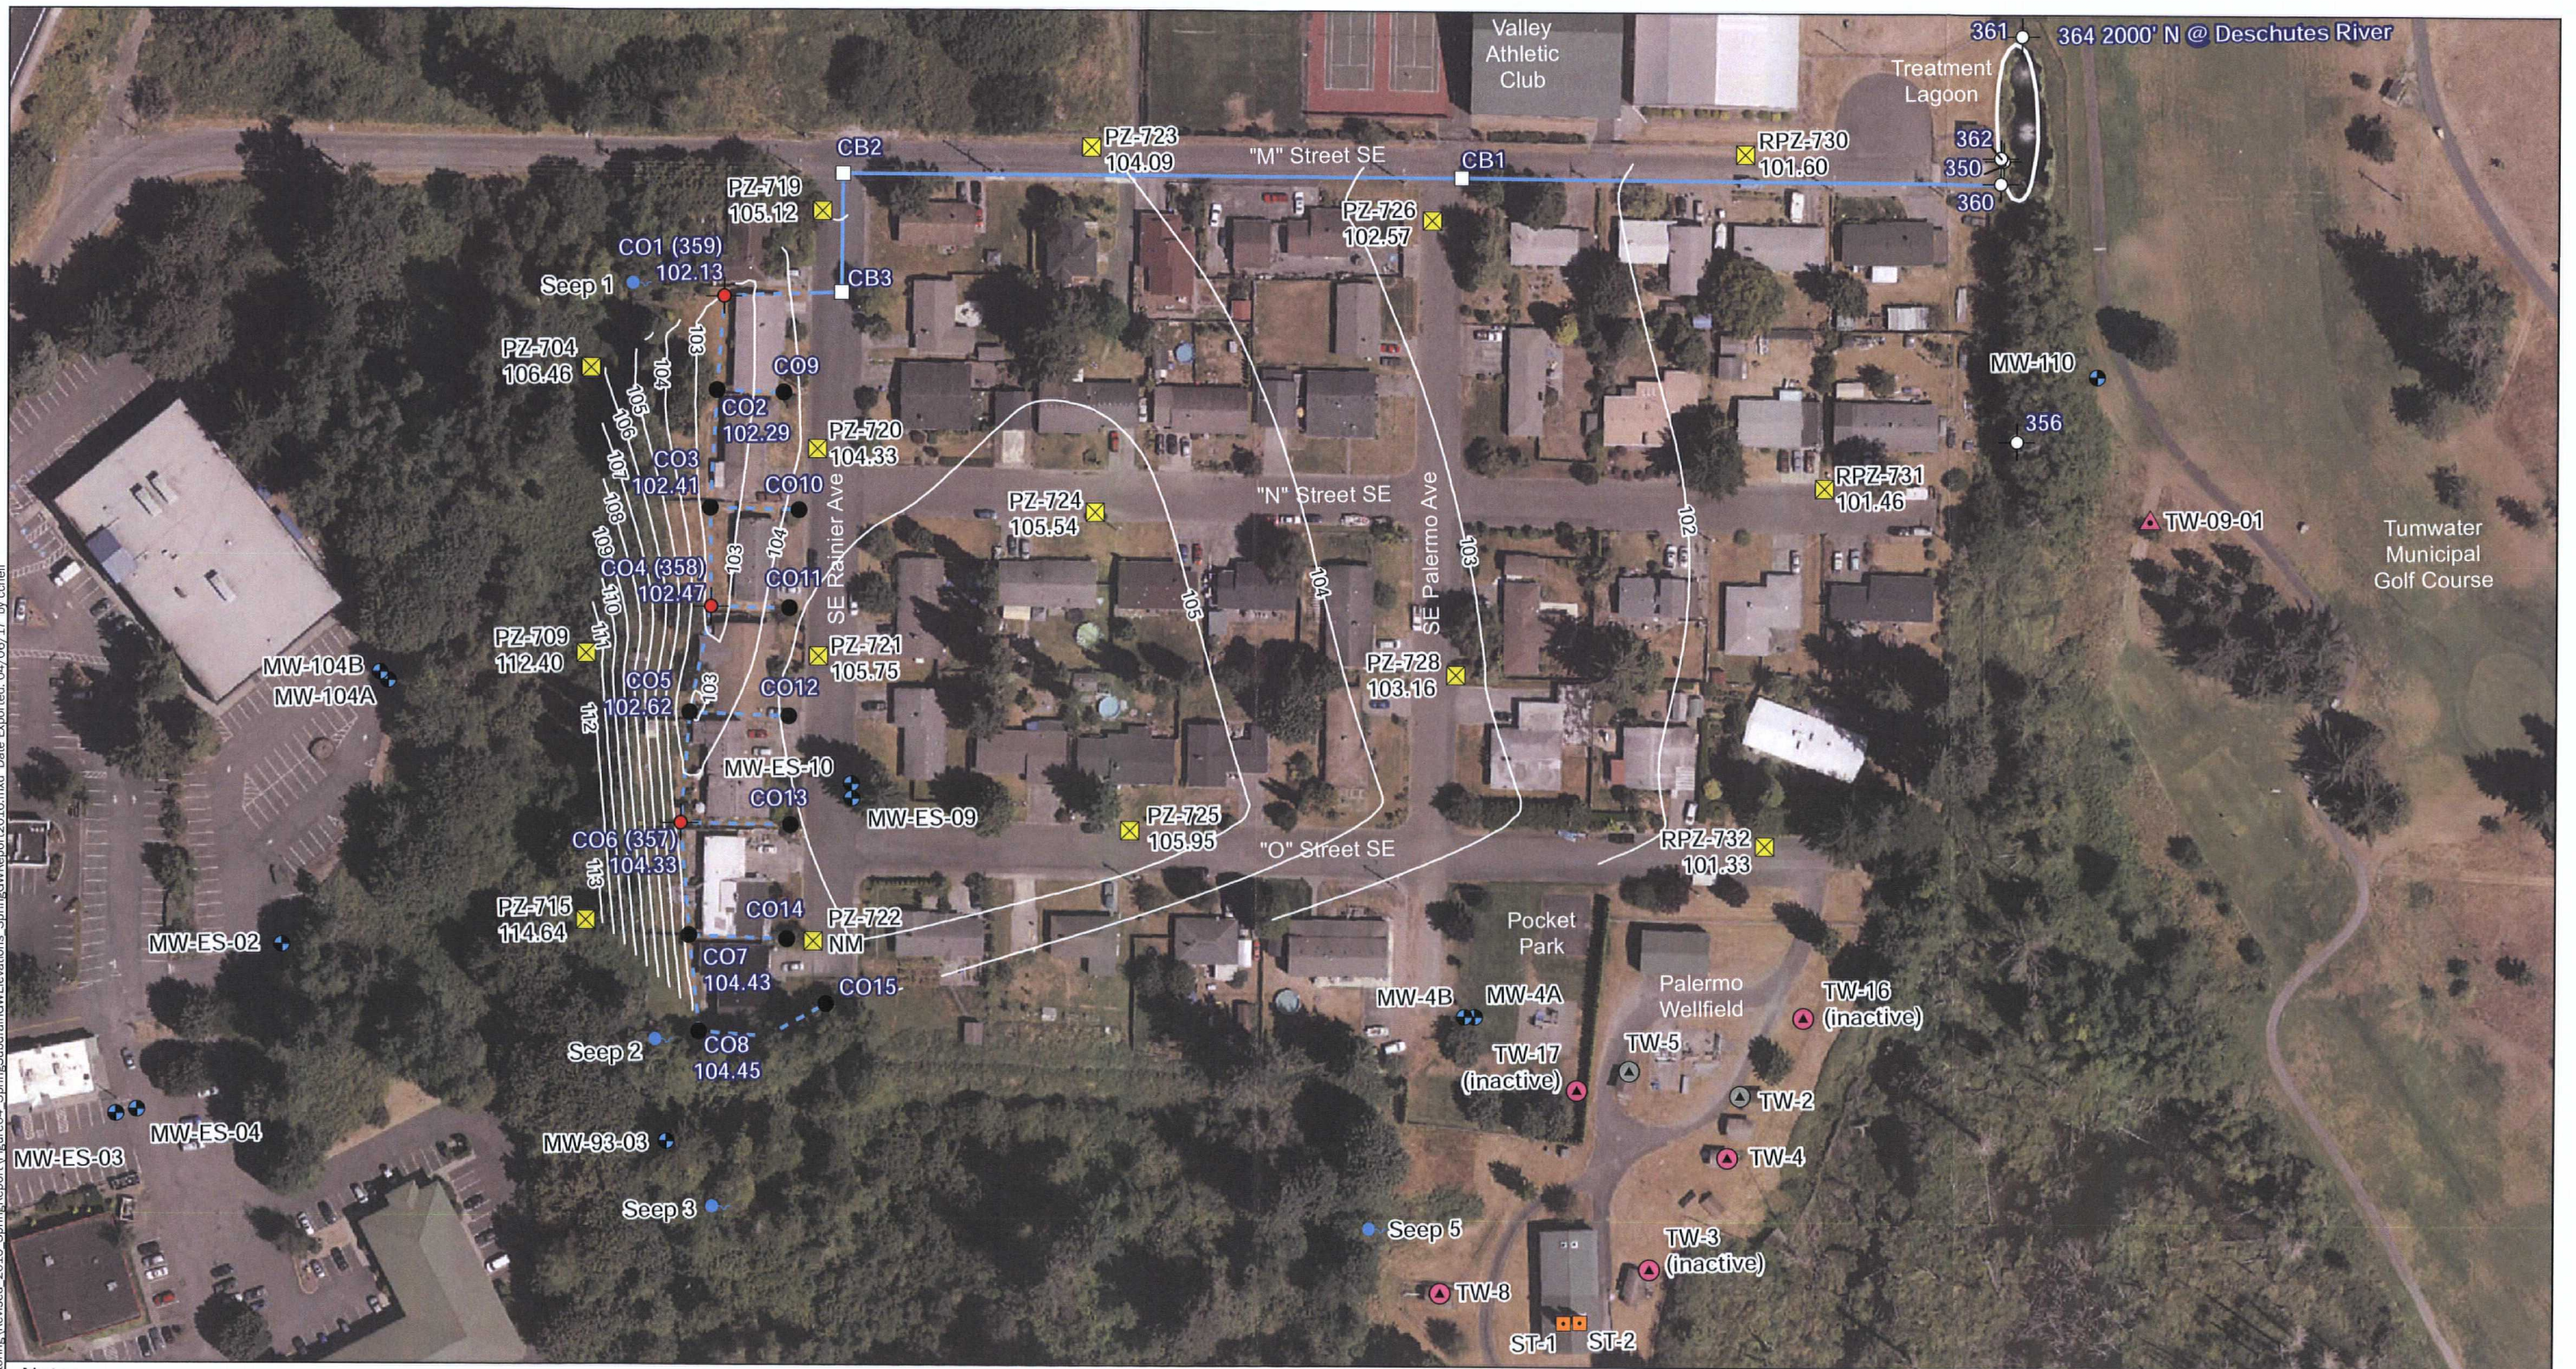
Figure 4

1. Contours were generated using Surfer 8.0 (Golden Software) contouring software using the natural neighbor gridding method from water levels measured on April 18th and 26th, 2016.

Depth to water measurements were collected from the Neighborhood piezometers, the subdrain cleanouts and the tightline catch basins using an electronic water level indicator. The measurements were used to calculate groundwater elevations in the Neighborhood (Table 4 and Figure 6).

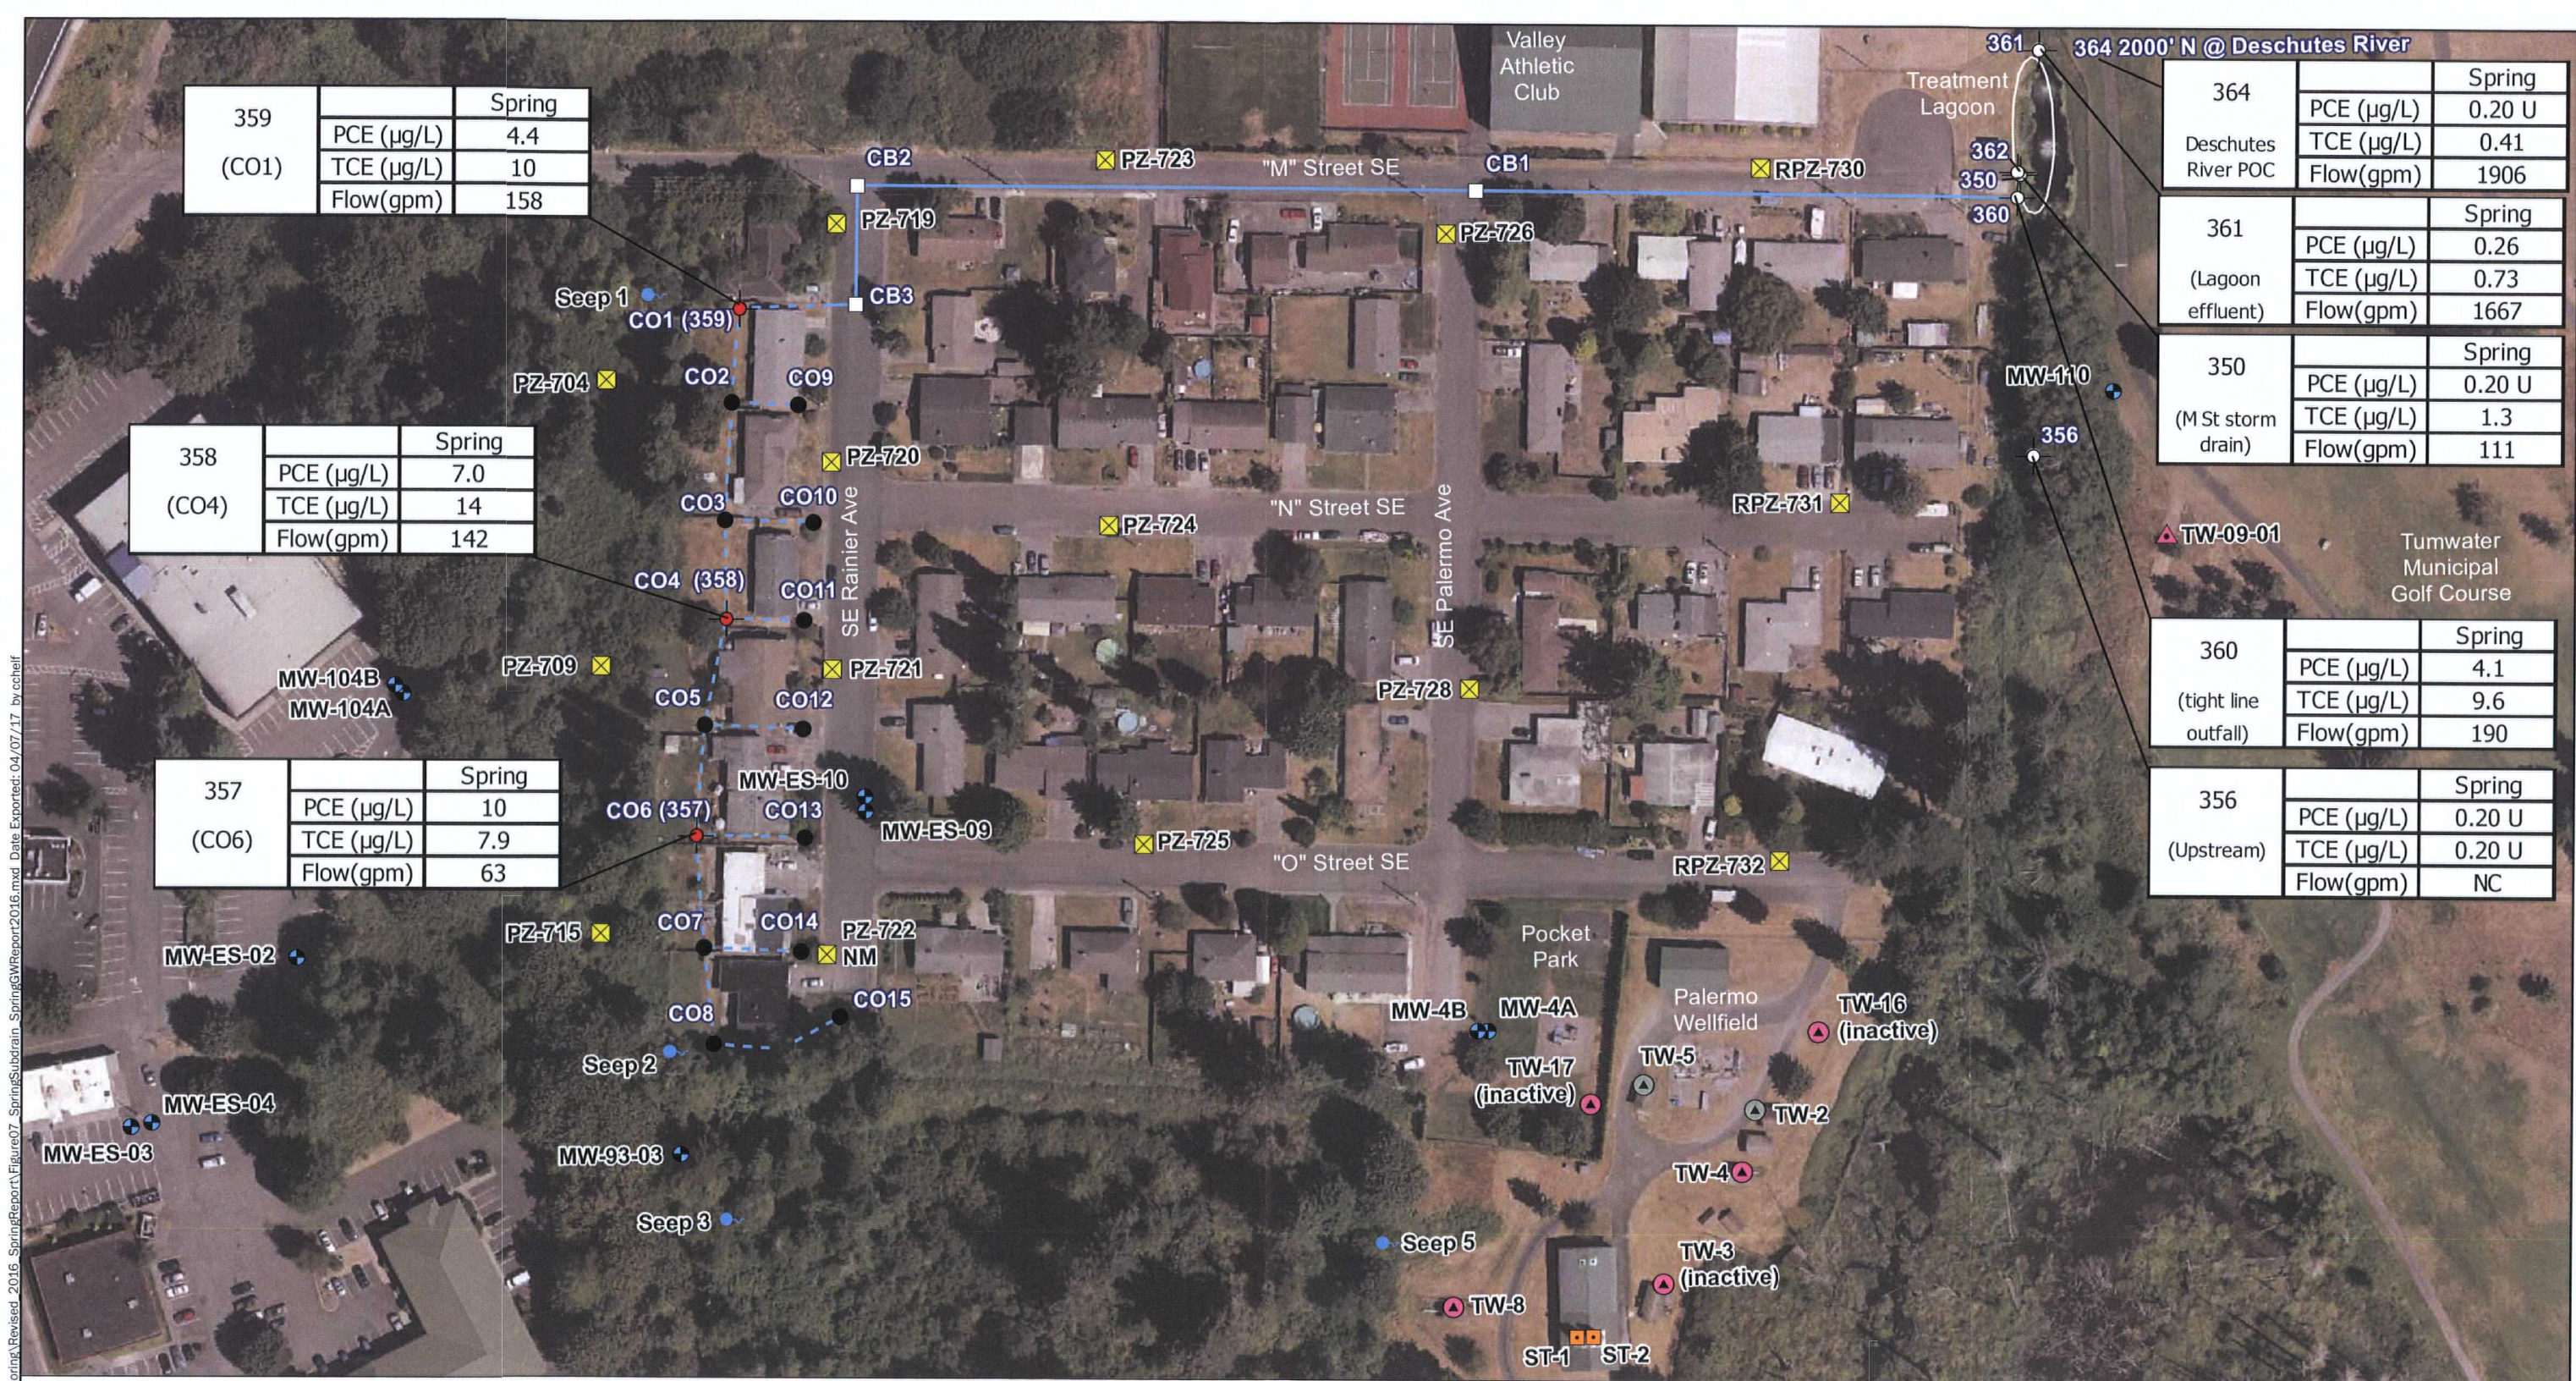
1. TW-3, TW-16 and TW-17 are installed but not operating.
 2. Subdrain and lagoon samples were collected on April 26, 2016.
 3. The locations of all features shown are approximate.

Spring 2016 - Subdrain and Treatment Lagoon
Monitoring Results, Palermo Neighborhood
